SERVICE BULLETIN		
Note No.	SVC-FSB-0043	
Release Date	12/05/2016	
Contact	ngceoservice@ngc.com

eDrive AC Input and SFX Checkout Guide

This technical note describes how to troubleshoot common faults in the eDrive.

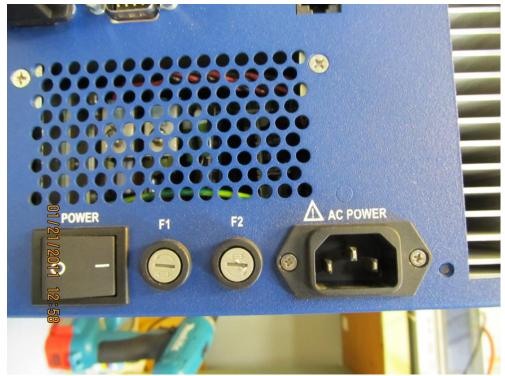
Figure 1: AC Power Switch

On the rear on the eDrive, the AC power cord connects at the IEC AC POWER input connector. From this input connector the power routes to the two fuses, **F1** and **F2**, and then to the **POWER** rocker switch. In normal operation, the **POWER** rocker switch is turned ON (I), and the eDrive soft on/off is controlled through the **Front Panel Power** switch.

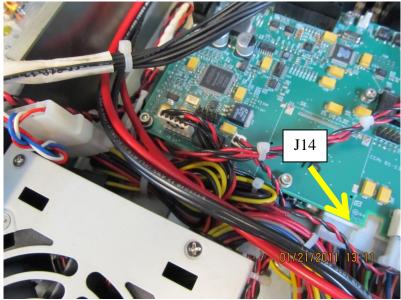
Figure 5: J14 Connector

Turning the rear panel **POWER** switch **ON** powers the internal SFX power supply. The SFX supply powers up in standby mode to allow for the soft on/off feature. In standby mode, only 5V standby voltage is enabled and the fan does not run so there is no visual indication that it is on. The standby 5V (5V SB) routes from the SFX **P1** main power connector (pin9) to the eDrive System Controller board at connector **J14**.

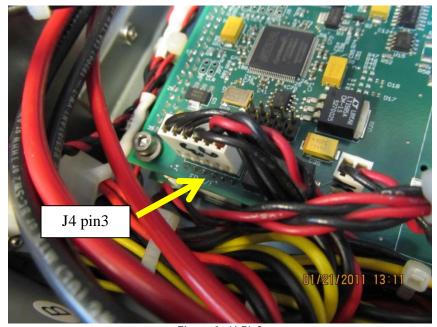
Figure 6: J4 Pin3

From the SC board, 5V SB routes from intra-board connector **J7** on the SC and to the EM board at **J4**. The 5V SB can be measured at pin 3 of the **J4** FP I/F connector on the EM. GND is on pin 4. **J4** is the Front Panel Interface connector and connects wires from Expansion Module **J4** to Front Panel **J7**. 5V SB can be measured at Front Panel connector **J7** pin3.

Examine the cable and connector wiring at **J7** on the front panel circuit board and at **J4** on the Expansion Module board. If you can monitor the 5V standby voltage while the system is operating and catch it going low at the pins of EM connector **J4** pin3, that would be an indication that the SFX supply is bad, or something to do with the AC power wiring leading up to the SFX supply is bad. If the **5V** standby voltage stays high when the eDrive shuts off randomly, then the **PWR-CTRL** signal should be monitored. If the **PWR-CTRL** signal is not staying at 0V, then something on the front panel circuit board could be working incorrectly.

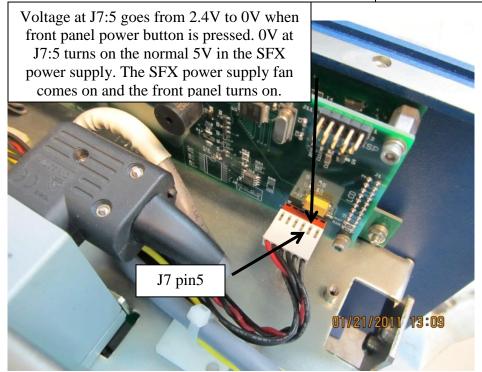
Figure 8: J7 Pin5

The 5V standby voltage powers the microcontroller circuitry on the front panel. When the Front Panel **POWER** button is pressed, the microcontroller pulls the PWR-CTRL line low. This signal can be measured at connector **J7** pin5. When the eDrive is OFF, the PWR-CTRL voltage on **J7**:5 should be approx. 2.4V. When the **POWER** button is pressed, the PWR-CTRL voltage at **J7**:5 should drop to 0V.

FP J7 Pin5 routes back to the EM at J4 pin5, and then through the intra-board connector to the System Control board, and back to the SFX supply on SFX P1 main power connector pin 14. When the SFX supply gets a low (0V) signal on this line, it enables the full output of the supply and provides the main 5V and +/-12V to the rest of the eDrive circuitry.
