SERVICE BULLETIN		
Note No.	SVC-FSB-0043	
Release Date	12/05/2016	
Contact	ngceoservice@ngc.com

eDrive AC Input and SFX Checkout Guide

This technical note describes how to troubleshoot common faults in the eDrive.

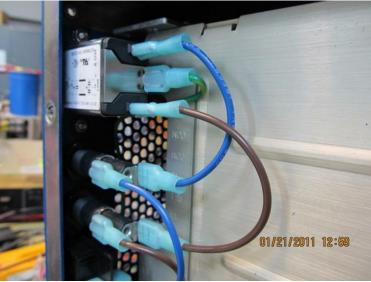
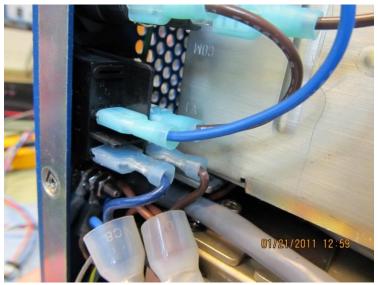
Figure 2: Fuses View 1

Power is routed from the power cord to the power switch and to the fuses.

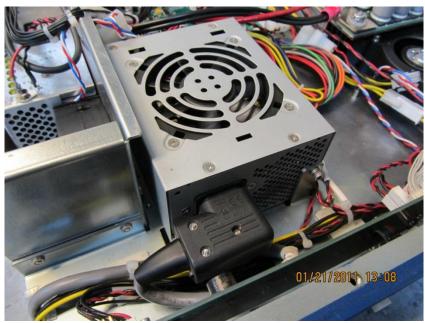
Figure 4: Internal Power Supply

Turning the rear panel **POWER** switch **ON** powers the internal SFX power supply. The SFX supply powers up in standby mode to allow for the soft on/off feature. In standby mode, only 5V standby voltage is enabled and the fan does not run so there is no visual indication that it is on. The standby 5V (5V SB) routes from the SFX **P1** main power connector (pin9) to the eDrive System Controller board at connector **J14**.
